**Docket No. 217 – Development and Management Plan Inspection**

Northeast Utilities Service Company Certificate of Environmental Compatibility and Public Need for the construction of a 345-kV electric transmission line and reconstruction of an existing 115-kV electric transmission line between Connecticut Light and Power Company's Plumtree Substation in Bethel, through the towns of Redding, Weston, and Wilton, and to the Norwalk Substation in Norwalk, Connecticut.

**Date:** June 20, 2006

**Location:** 345kV Underground Route

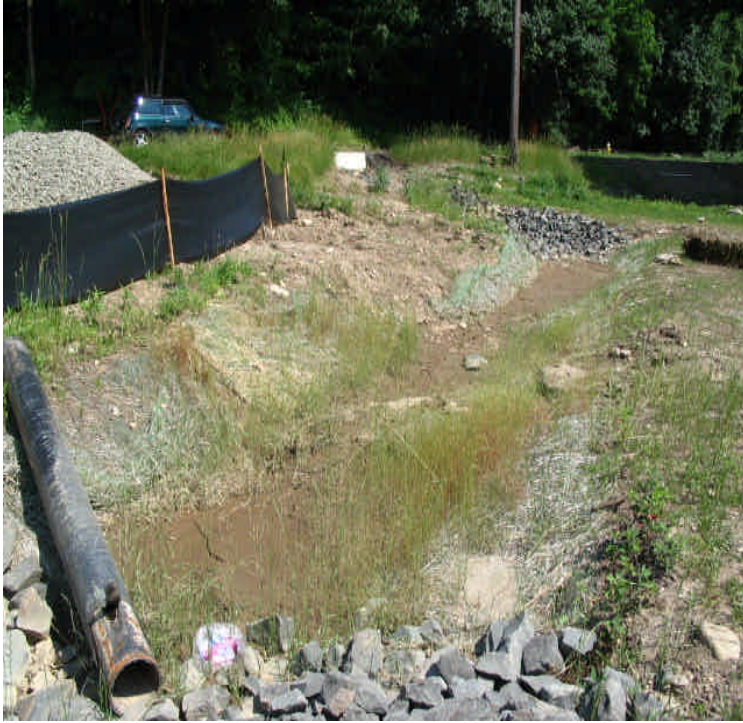
**345kV (Norwalk Junction and Rt 7) Photo on the left shows the silt fence installed at NJ at the base of the remaining stockpiles. Photo on the right shows the work just north of NJ. This area will be temporarily restored soon per landowner's request. Protect catch basins along here. 6/20/06**

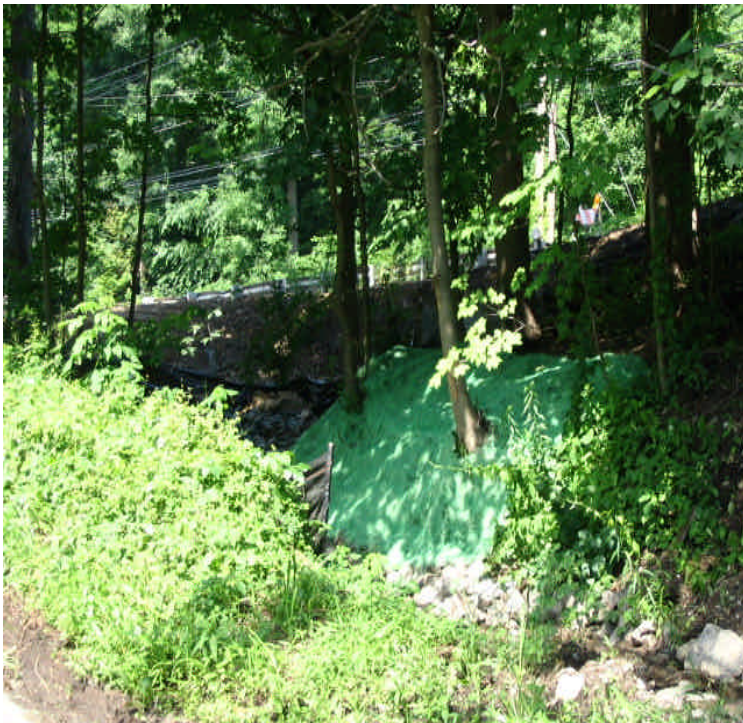
**Photo on the left shows the area near Old Danbury Rd where the slope was restored with an erosion control blanket. (School Rd HDD): Photo on the right shows the HDD School Rd site restored and hydroseeded. 6/20/06**

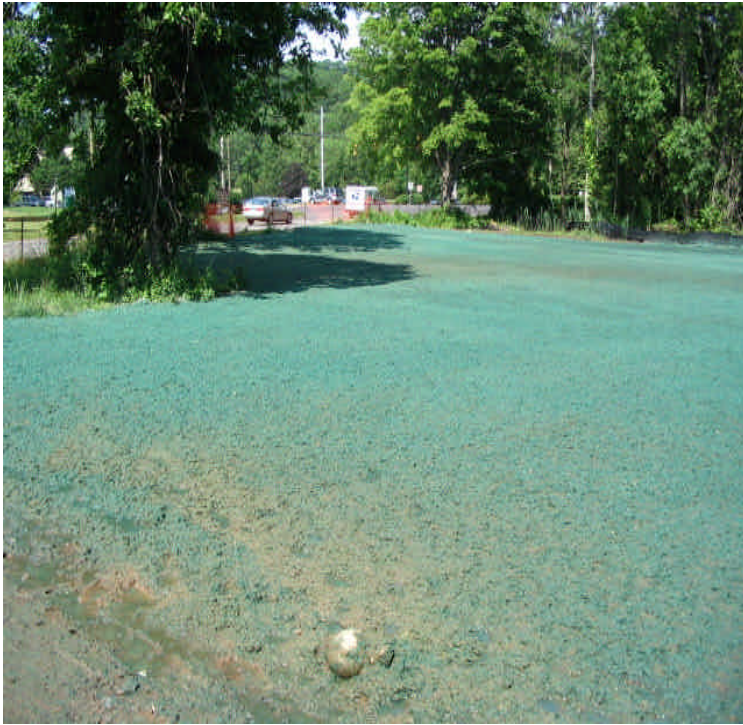
Photo on the left shows another view of the old HDD site. The area is restored for future event parking per request of the town. Photo on the right shows the area beyond the basin to the south which has been restored and seeded with wetland species. 6/20/06

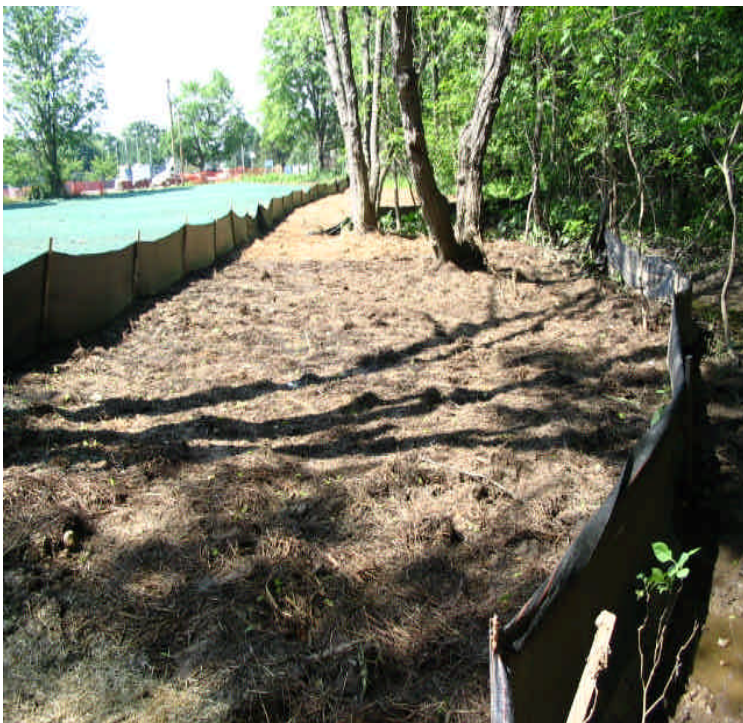
Photo on the left shows the restored area to the east of the basin. This will also be allowed to return to wetland vegetation. Photo on the right shows where accumulated sediment was removed by hand from the wetland, restoring a natural swale here. 6/20/06

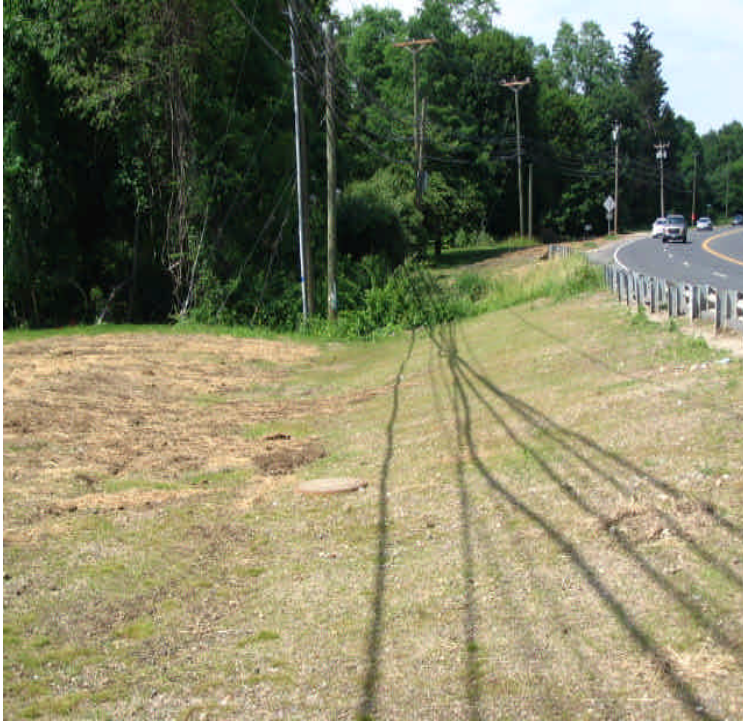
**(Rt 7) Photo on the left shows where new grass growth is evident at the old HS jack and bore site following restoration. Photo on the right shows where recently accessed roadside areas have been seeded and mulch near the Zion church. 6/20/06**

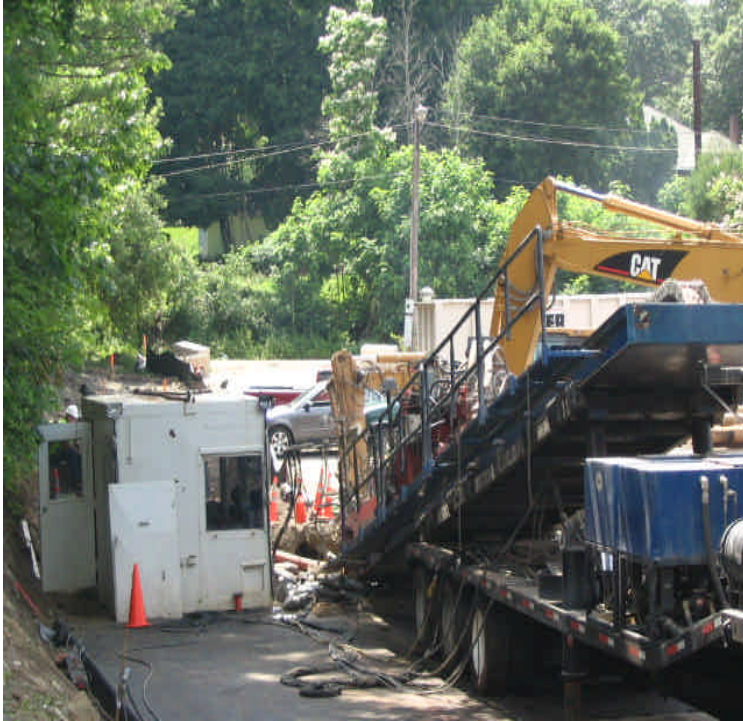
**(New Georgetown HDD): Photo on the left shows the new HDD area off Rt 107. Silt fence is up along the drilling pit and the temp control house is in place. (Georgetown Deli): Photo on the right shows one of the recently restored portions of the bank where vegetation is returning. 6/20/06**
